An Investigation of a Helical Gear Crack Used in a Crop Shear

Charnont Moolwan¹ and Samroeng Netpu²

Abstract

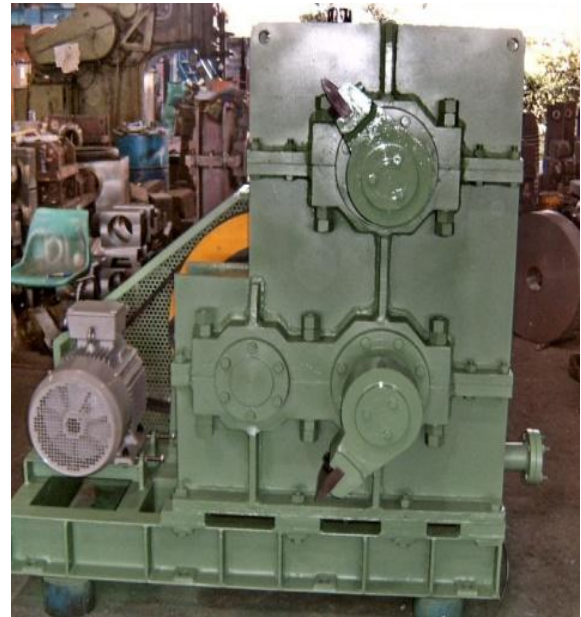
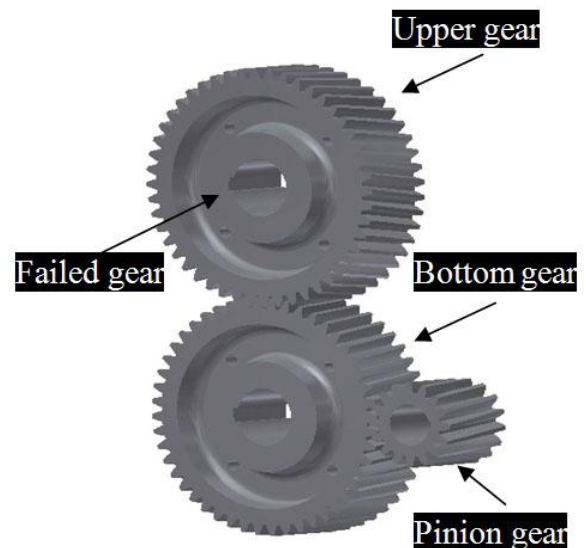
Fig. 1. The crop shear and layout of the failed helical gear

The failed helical gear being investigated was used in a crop shear for hot rolling mill. The failed gear has 45 teeth and the face width of 90 mm. The module of the gear is 12 mm, the helix angle is 10 degrees. A crack of gear was reported after heat treatment process. Relevant photo of the crop shear and layout of gear as shown in Fig. 1.

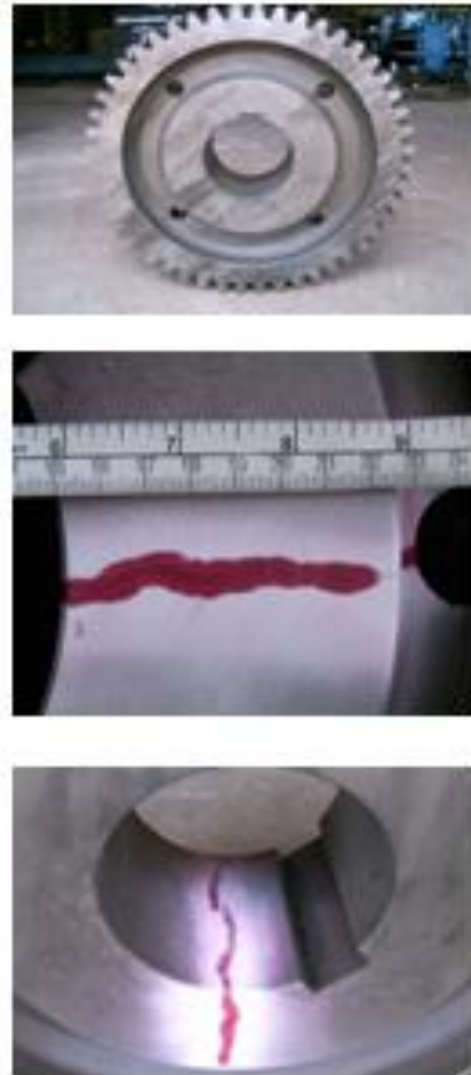
Fig. 3. Crack occurrence in the failed gear

The appearance of the failed helical gear from various perspectives is as shown in Fig. 3. It can be seen that the cracks of the failed gear from heat treatment are long and passed through the gear hub. Dye penetrant technique was employed to enhance visual inspection of the crack and to reveal the nature of crack more fully.

1. The cracks of the failed gear happened at the process of the casting.
2. It is recommended that extreme care must be inspected the casting defect before machining station.

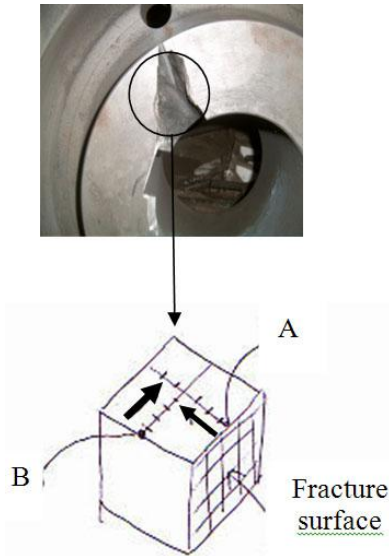
Fig 4. Hardness testing of the sample

Fig. 4 shows the position that was cut from the cracked area for hardness testing.

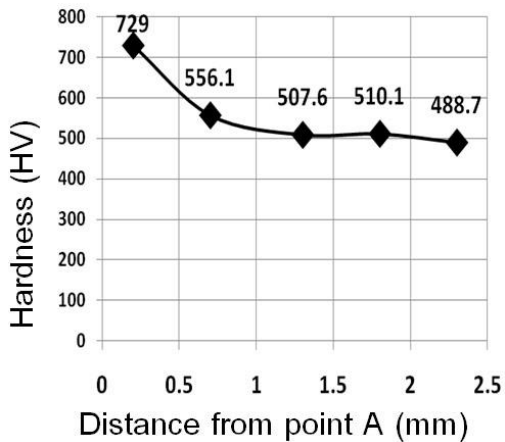
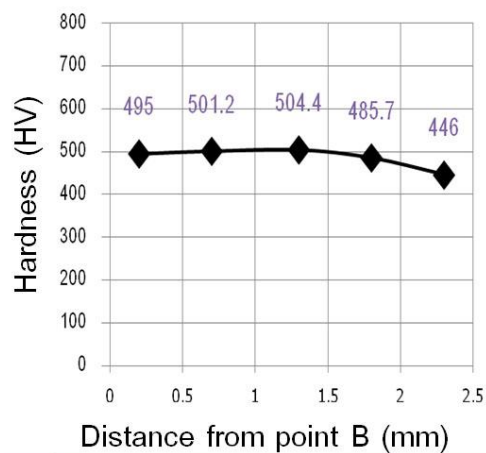
Fig 5. Microhardness profile of the failed gear

Fig. 4 shows the measurement of hardness at different positions along the arrow lines. Result of hardness testing are shown by graph as in Fig. 5 that shows the following results. When measuring from the crack at Position A towards the center of the failed gear, the hardness diminished from 729 HV down to 488.7 HV at the dept of 2.25 mm. But if measured inside the failed gear starting at Position B and went deeper, the hardness was similar: at Position B, the hardness was 595 HV and at the dept of 2.25 mm the hardness was 446 HV. It can be seen that the cracks of the failed gear happened before heat treatment because if the cracks happened during the process of heat treatment the hardness would be similar when measured from the crack towards the inside.

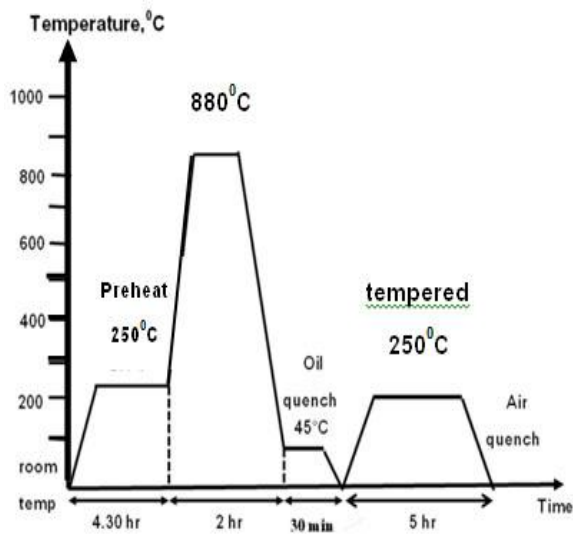
Fig. 6 Schematic of heat treatment

The heat treatment of the failed gear used the austenitizing temperature of 880°C and tempered at the temperature of 250°C as shown in Fig. 6 according to the standard of heat treatment of AISI 4140 steel.[8]
